# TORRANCE WIND FARM EXTENSION II ABNORMAL LOAD ROUTE ASSESSMENT

**DECEMBER 2022**

The Torrance Wind Farm Extension II is a proposed extension to the existing wind farm located north of Harthill, and within approximately 5 km distance to the M8 slip roads to the east and west. This Abnormal Load Route Assessment (ALRA) provides an assessment of land based routes to the wind farm site for the delivery of wind turbine components.

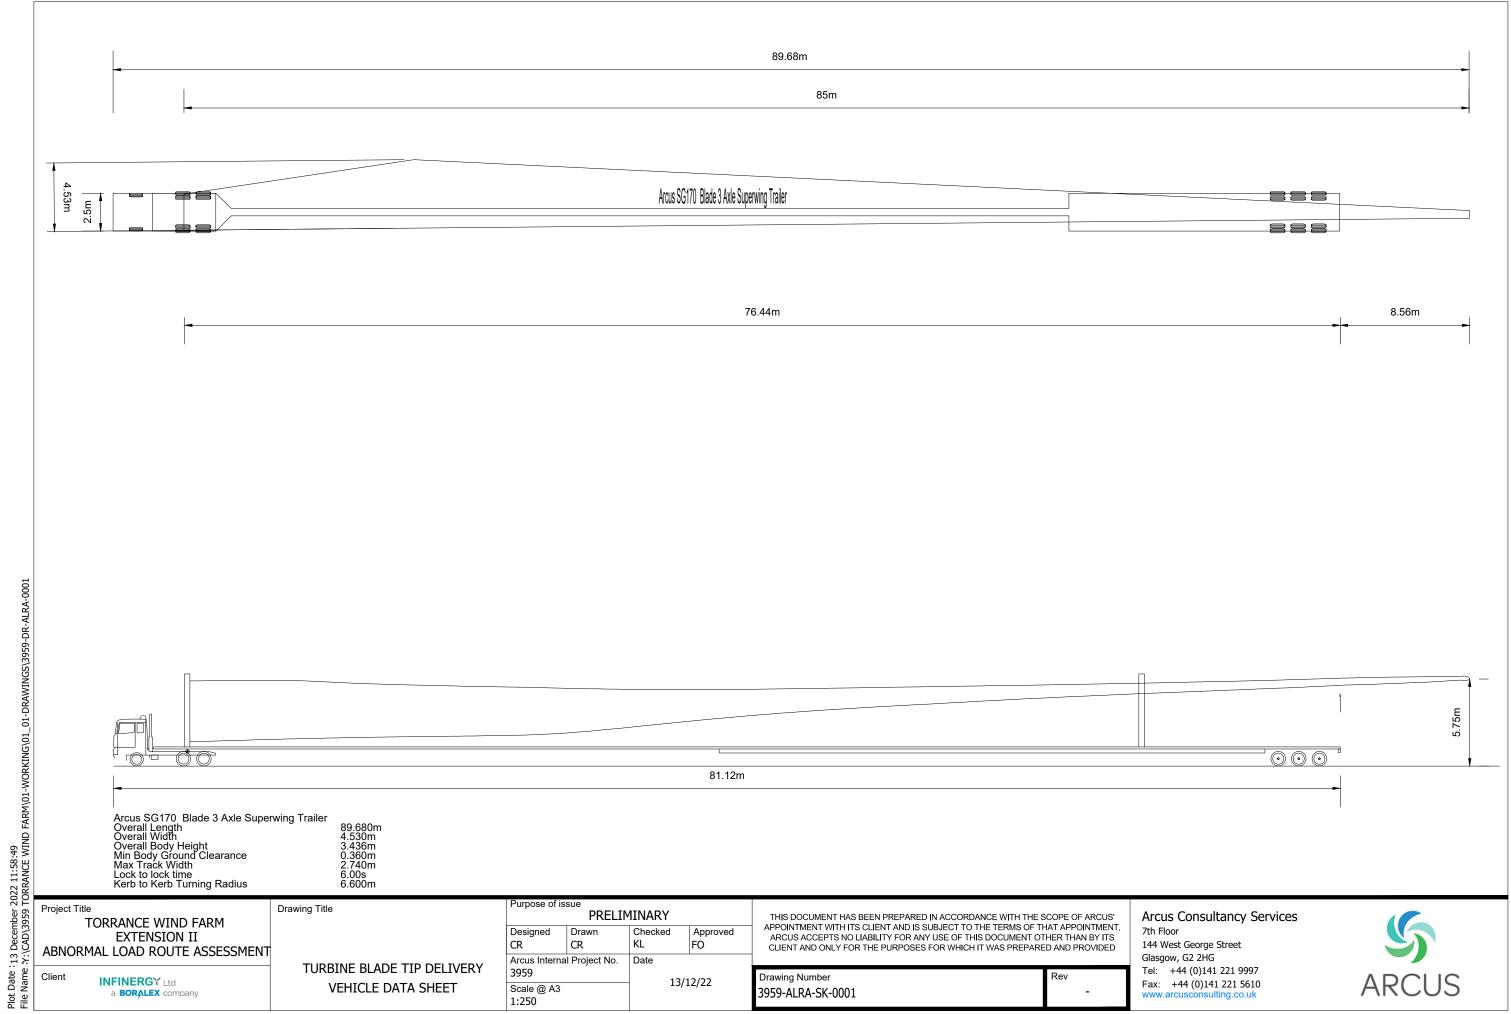
# **APPENDIX A – VEHICLE DATA SHEET**

This assessment is based upon an SG170 candidate turbine. The vehicle data sheet is included in Appendix A. Dimensions of the blade and corresponding delivery vehicle specifications are provided in the following tables.

Data	Source
Blade Trailer	Vehicle length – 81.12 m Blade overhang – 8.56 m	Arcus SG170 Blade 3 Axle Superwing Trailer

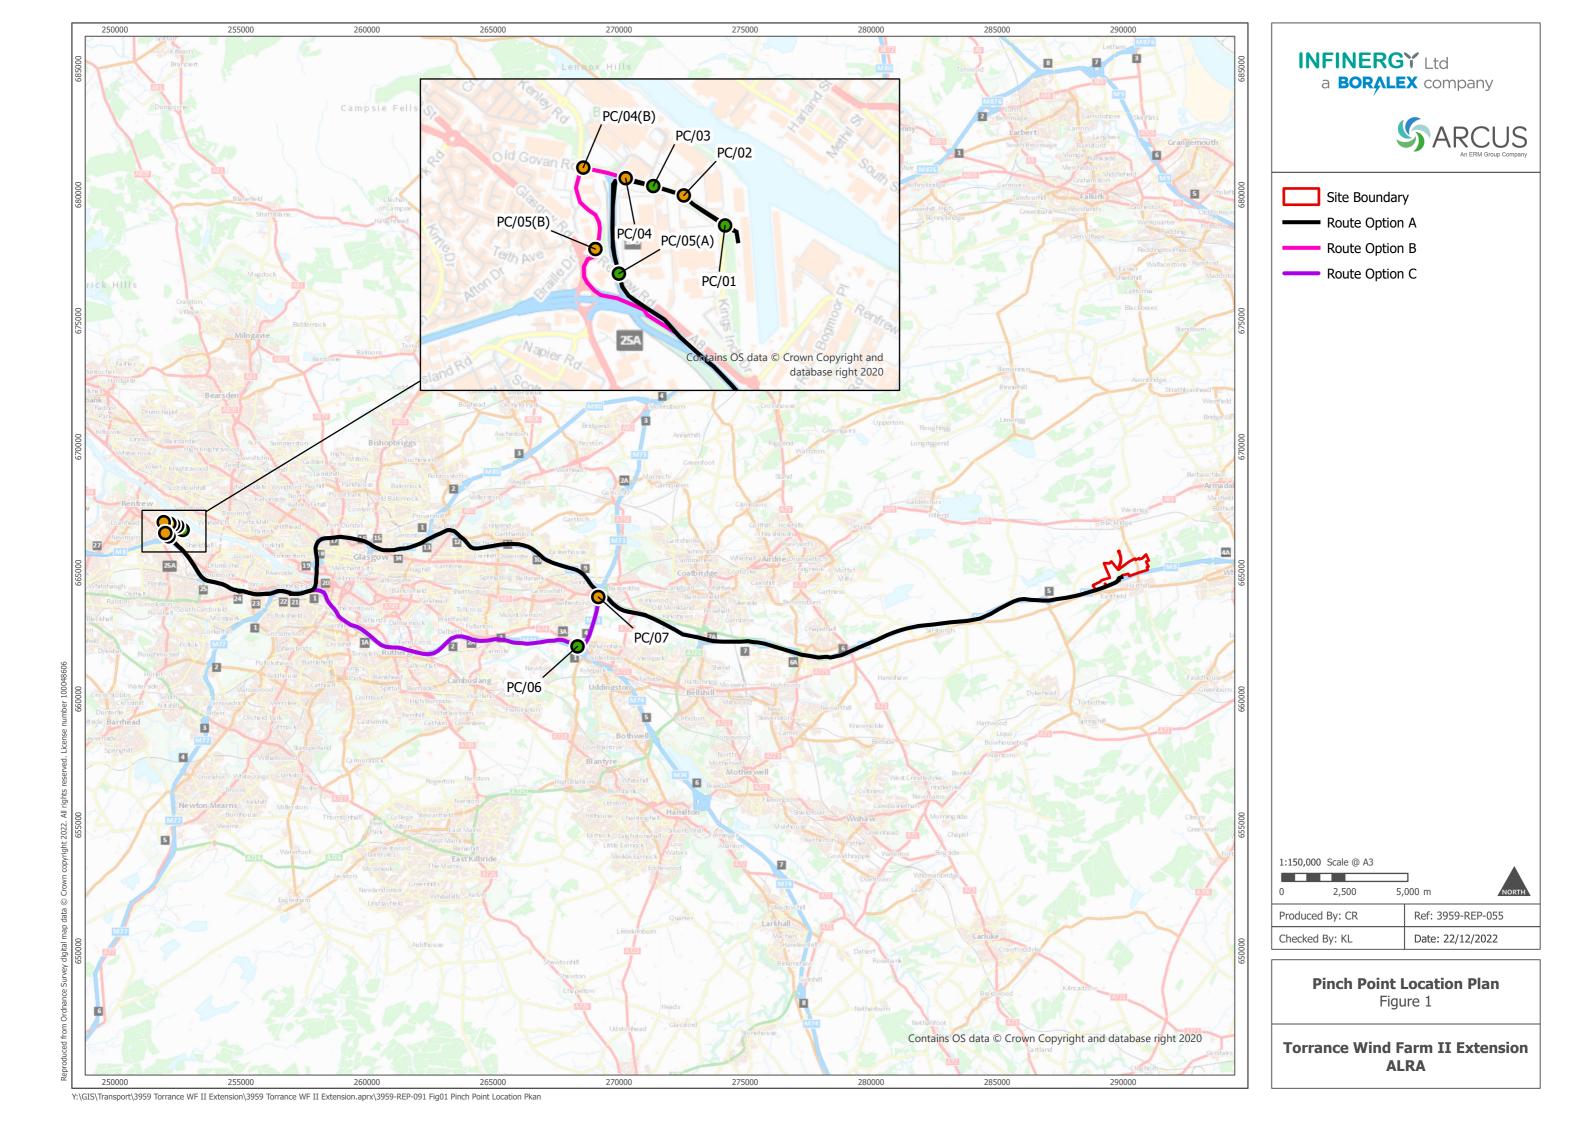
# **APPENDIX B – ROUTE TO SITE**

Wind turbine components will be delivered to King George V Dock, Glasgow for onward overland delivery to the Wind Farm Site. An overview plan of the routes assessed is provided in Figure 1 of Appendix A.

Route Option C, if used, would depart from Route A at Junction 21 of the M8. The following route would then be taken as shown on Figure 1:

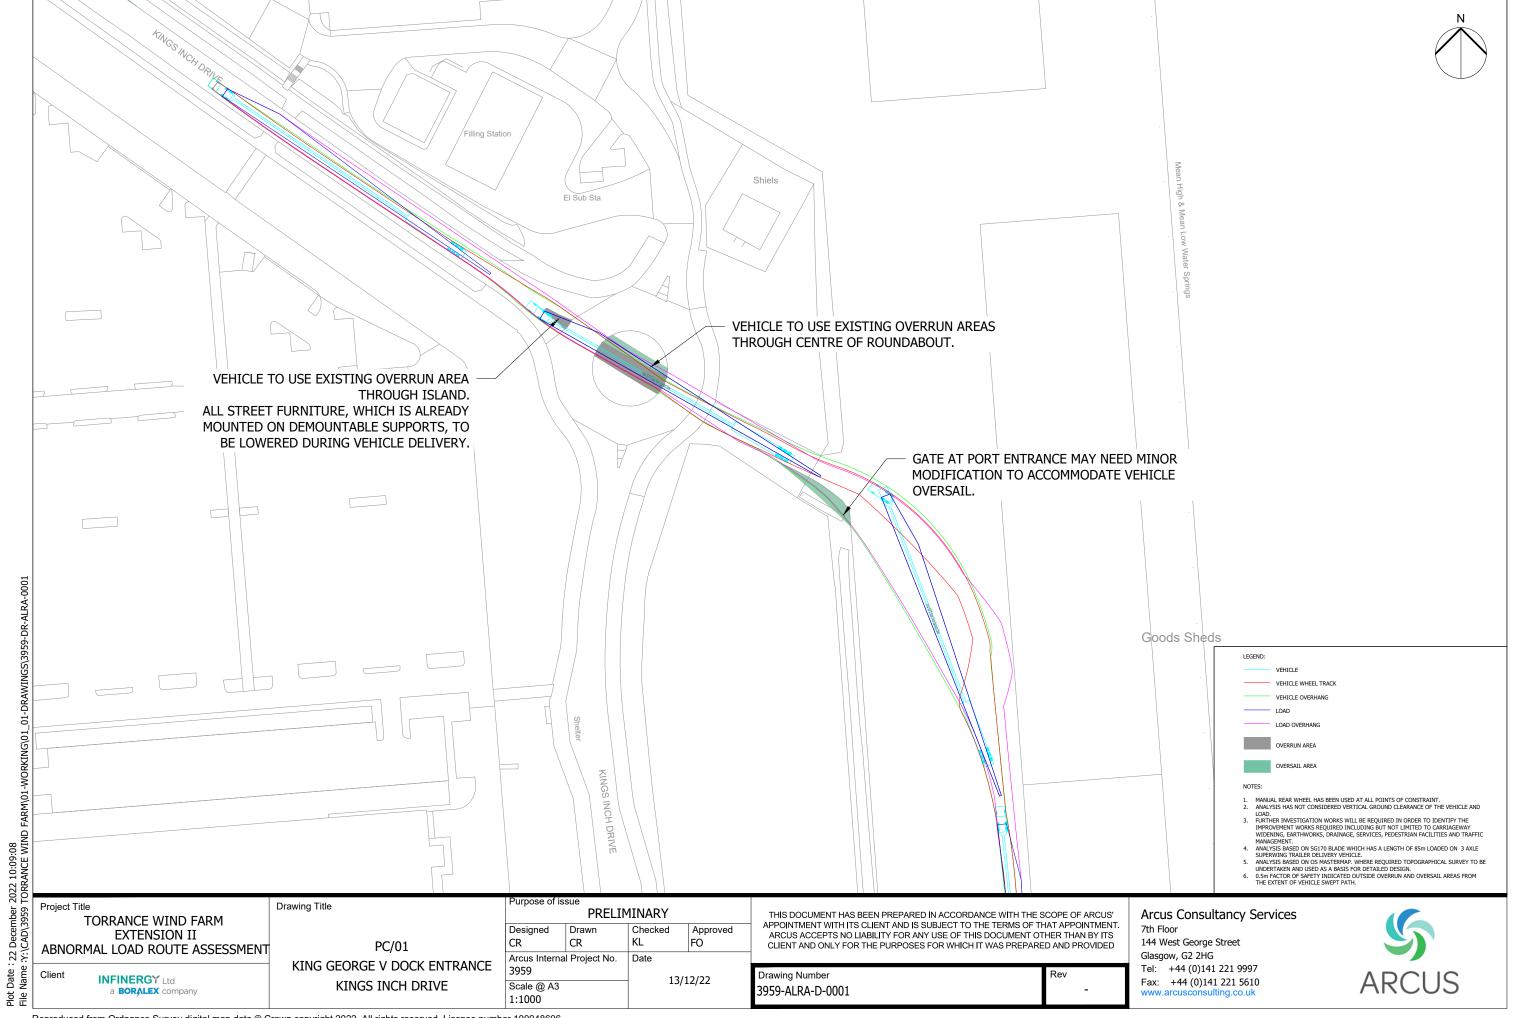
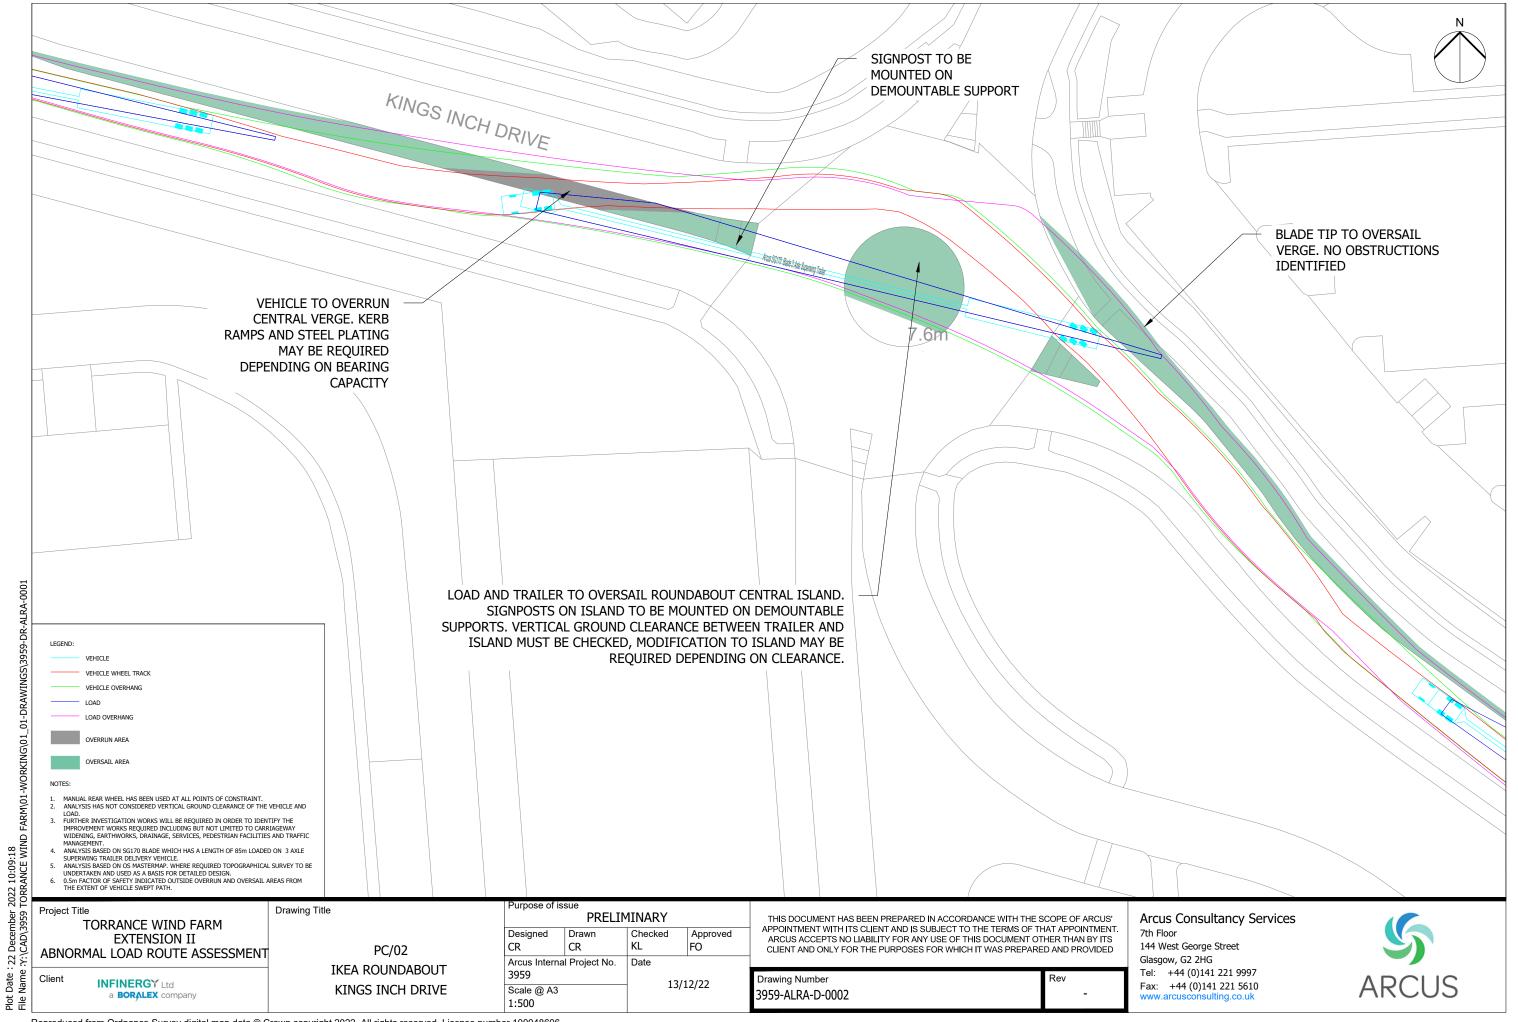
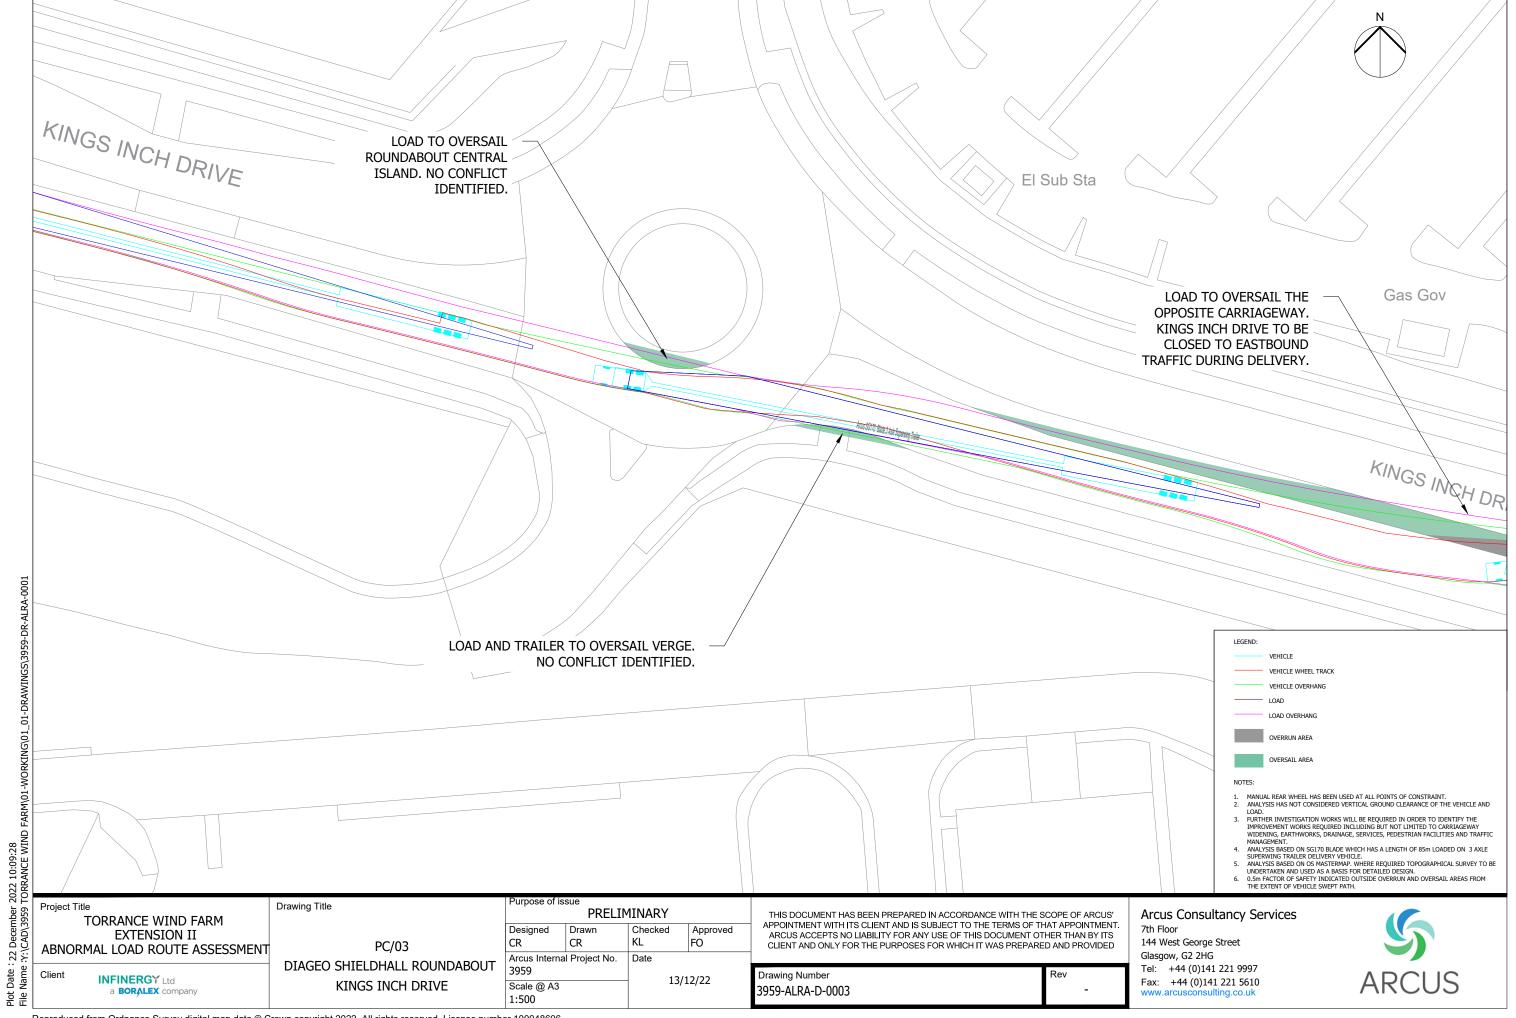
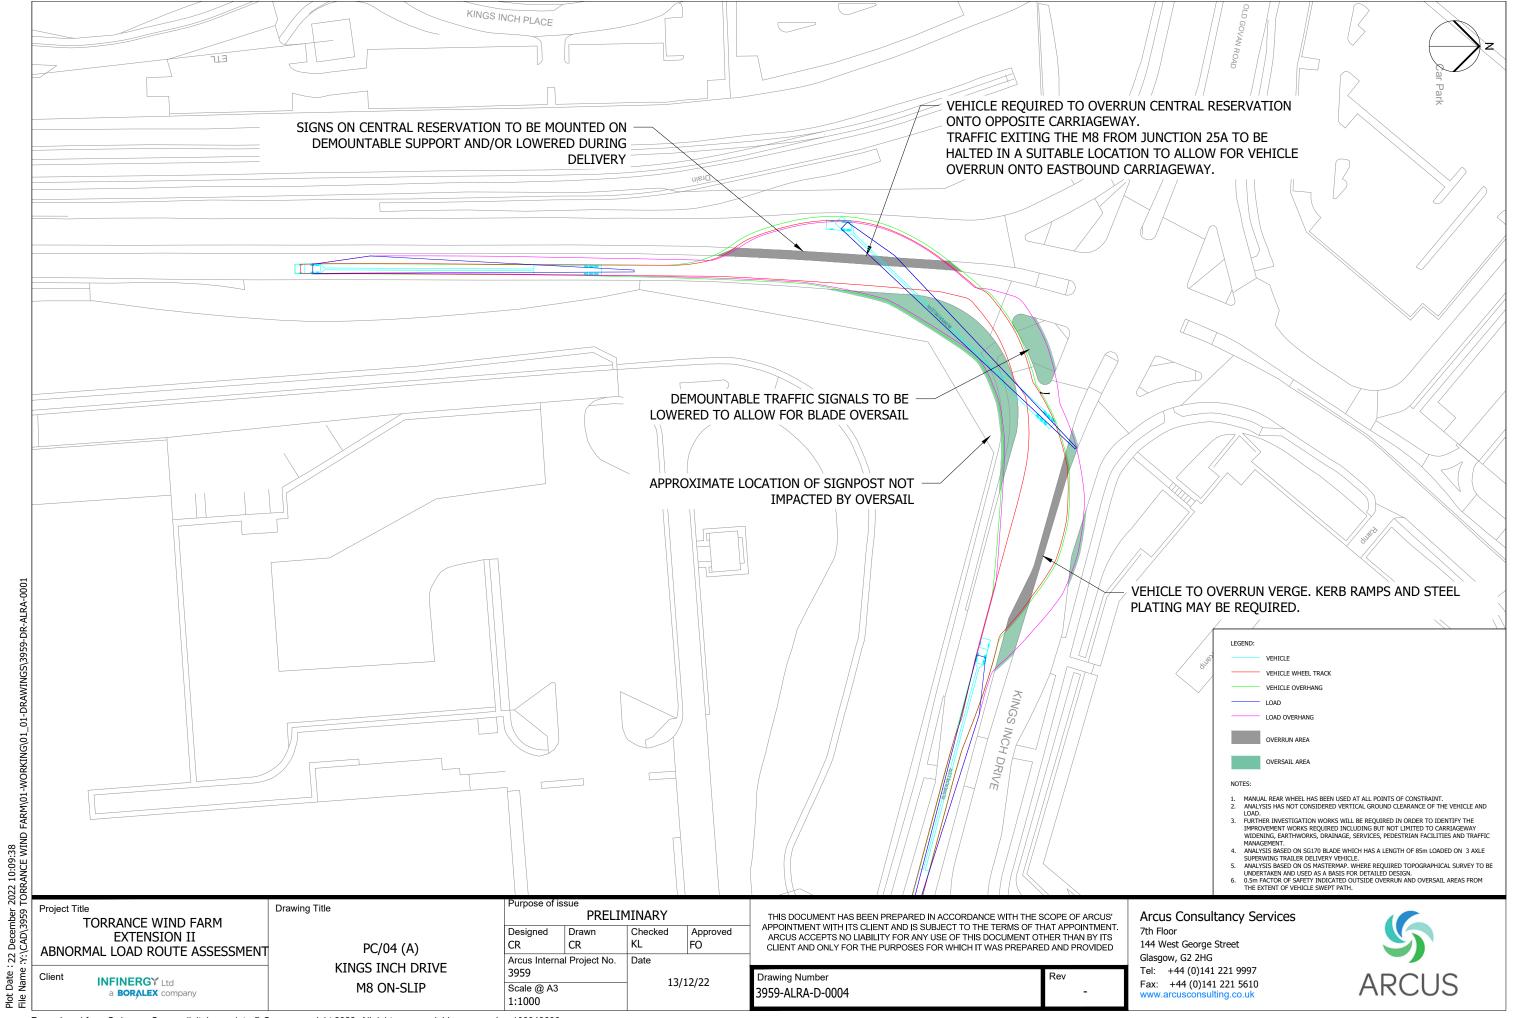
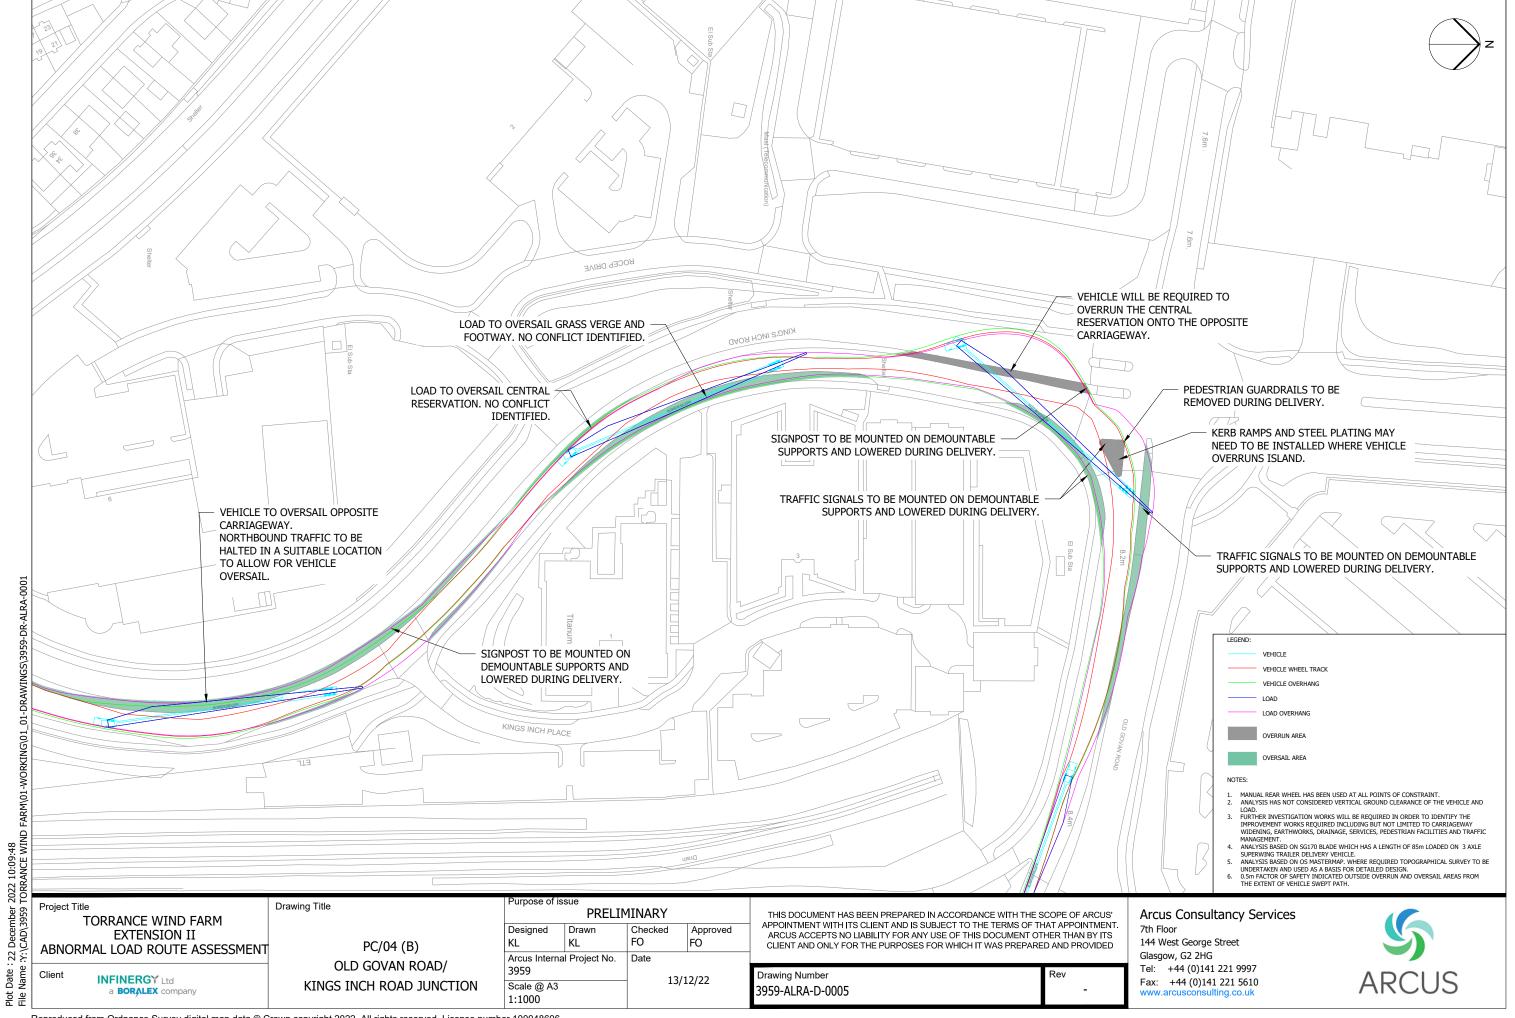
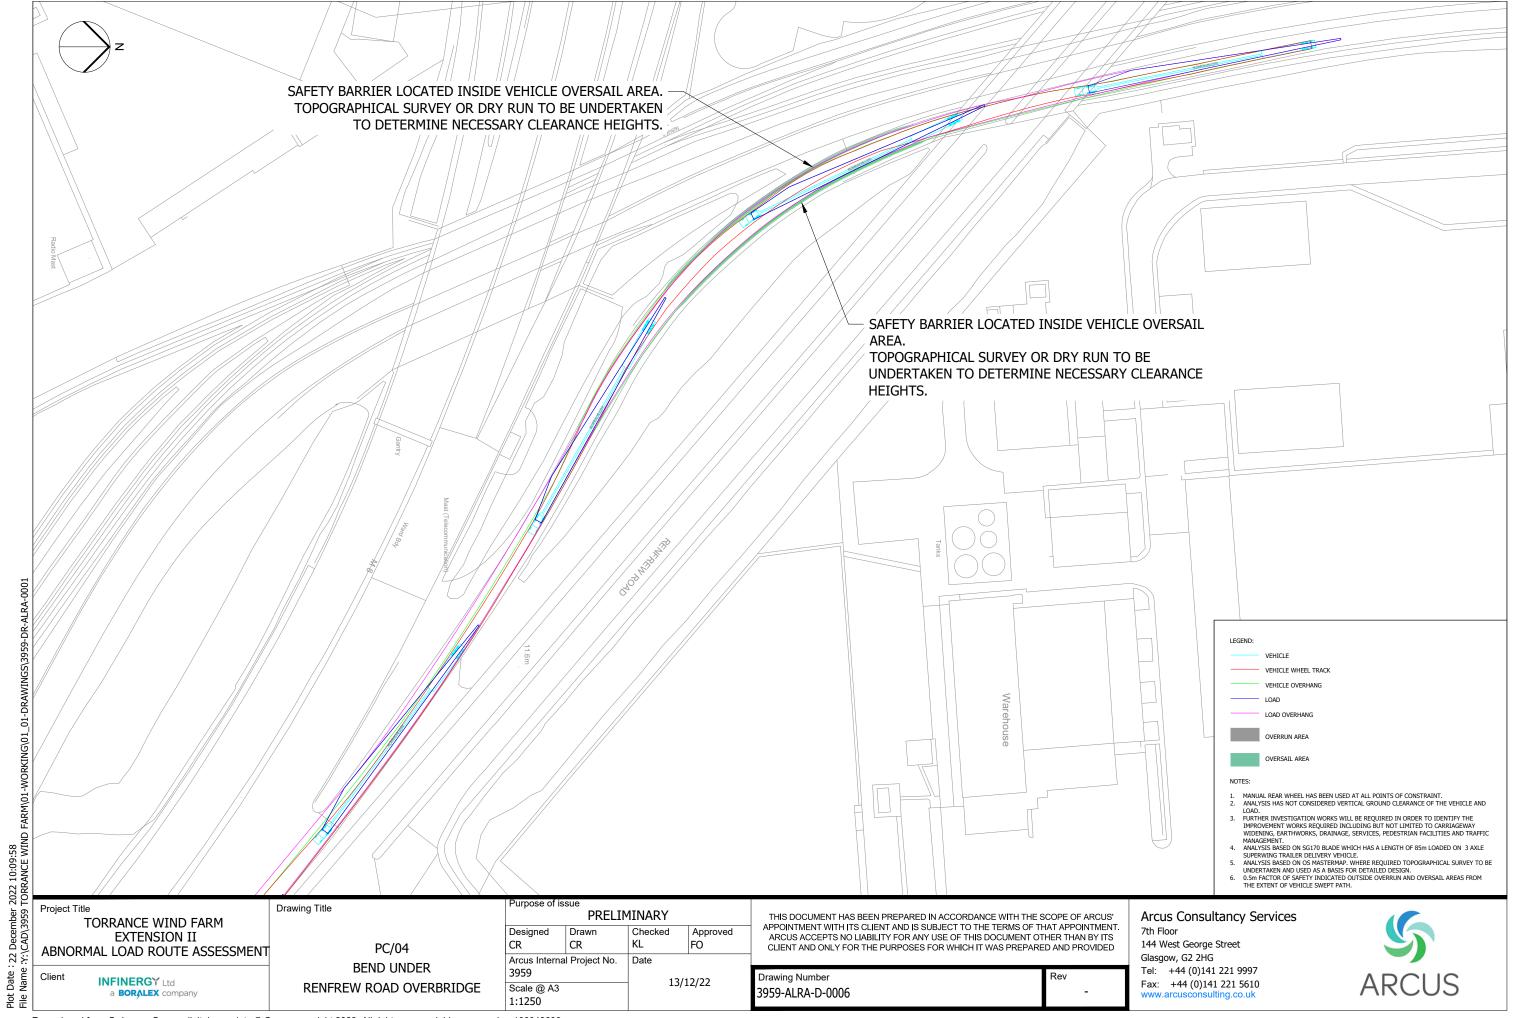
# APPENDIX C - SWEPT PATH ANALYSIS DRAWING

This ALRA is a desk based study which uses publically available Ordinance Survey (OS) mapping to conduct swept path analysis of pinch points on the proposed delivery route. Swept path analysis is conducted in AutoCAD using the Vehicle Tracking software and a bespoke delivery vehicle developed for this ALRA.

PC/03	Diageo Shieldhall Roundabout, Kings Inch Drive	Vehicle will oversail the central reservation onto the opposite carriageway after exiting the roundabout. in various locations as shown on 3959-D-ALRA-0003, no conflicts have been found.	Kings Inch Drive to be closed to eastbound traffic during delivery.	Low
PC/04 (A)	Kings Inch Drive / M8 On-Slip	Vehicle will overrun in various locations as shown on 3959-D-ALRA-0004, creating conflict with existing road signs.  Vehicle will oversail in various locations as shown on 3959-D-ALRA-0004, creating conflict with existing demountable traffic signals.	Load bearing capacity in areas of vehicle overrun to be determined. If insufficient, then kerb ramps and steel plating will be required to allow for overrun.  Conflicting road signs in overrun area to be mounted on demountable supports and lowered on vehicles arrival.  Existing traffic mounts appear to be mounted on demountable supports, signals to be lowered on vehicles arrival.	Medium
